HUDSON RIVER BASIN  
WANATAQUE RIVER, PASSAIC COUNTY  
NEW JERSEY

# GREENWOOD LAKE DAM

## NJ 00187

### PHASE 1 INSPECTION REPORT NATIONAL DAM SAFETY PROGRAM

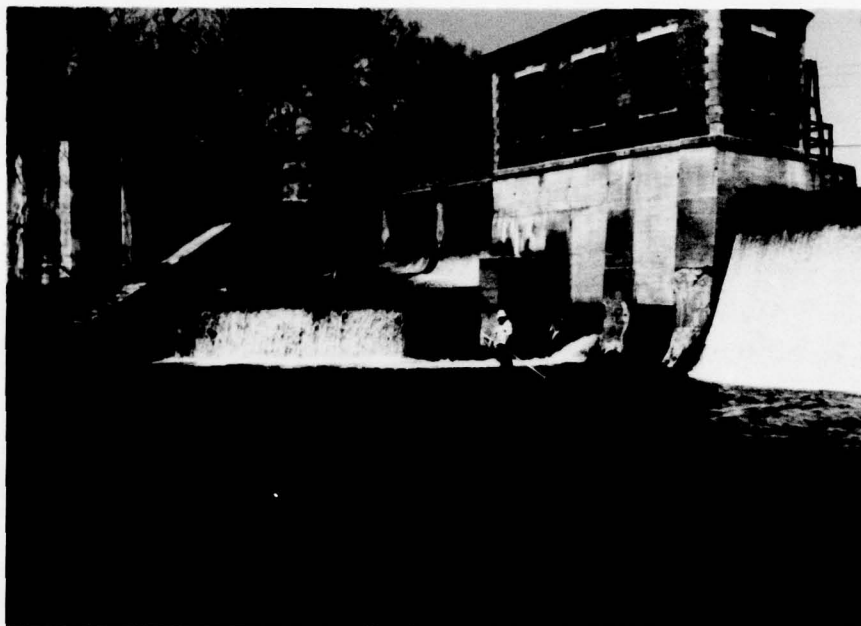
Photo No. 1 - Overall view of right side of dam from downstream. The right spillway, bridge structure, gate house and surge tank can be seen.

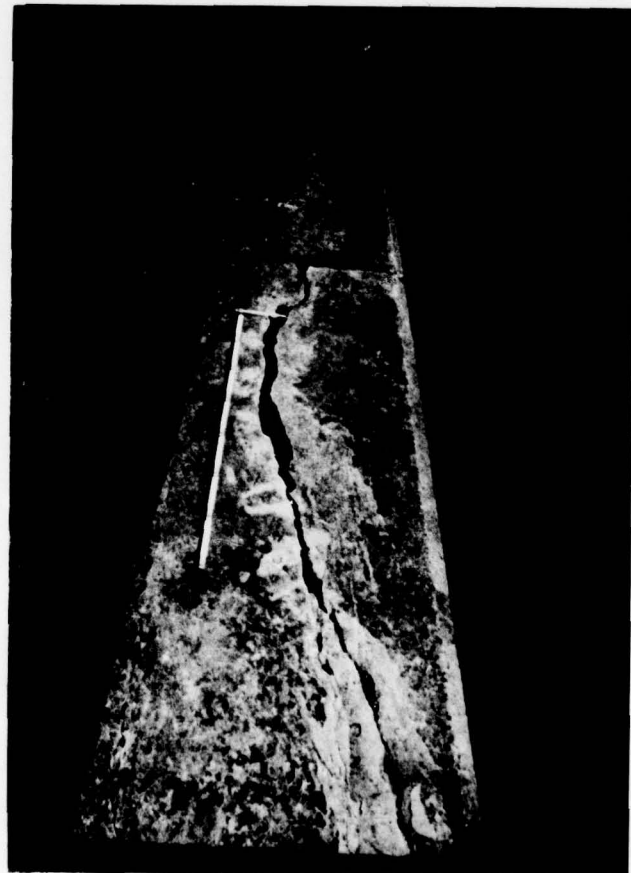
In view of the existence of cracks, the right bridge abutment should be investigated for possible undermining. The seepages noted downstream require further investigation but are not thought to constitute a hazardous situation.

Photo No. 8 - Detail showing the movement crack in the right wingwall, upstream of the footbridge.

(1) Repair all spalled, eroded and cracked concrete with epoxy cement.
